INSTALLATION RESTORATION PROGRAM

SITE ASSESSMENT REPORT VOLUME I

111th FIGHTER GROUP
WILLOW GROVE AIR RESERVE STATION
PENNSYLVANIA AIR NATIONAL GUARD
WILLOW GROVE, PENNSYLVANIA

FINAL SITE ASSESSMENT REPORT MOTOR POOL AREA, BUILDING NO. 352

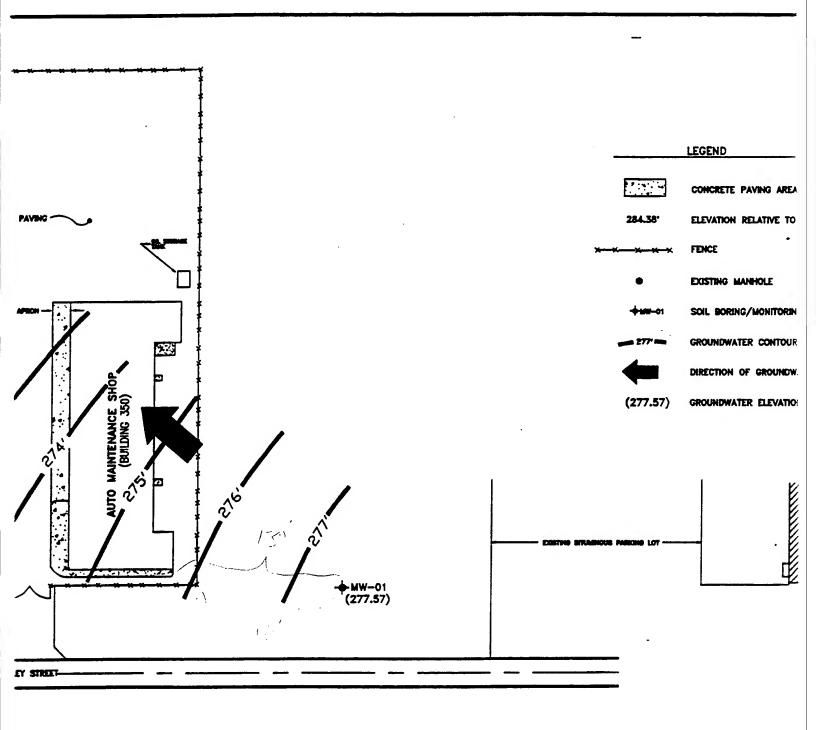
FIGURE 3.6 POTENTIOMETRIC SURFACE MAP 11/6/93 MOTOR POOL AREA WILLOW GROVE AIR RESERVE STATION

Groundwater flow direction in bedrock (under confined conditions) was toward the north and northwest during both SA phases conducted in 1993 and 1994. These SA data also proved consistent with the earlier 1988 RI data. Depth to groundwater in site wells which penetrate bedrock ranged between (approximately) 6.5 ft BGS to 13.1 ft BGS during both phases of the SA. Depth to groundwater in soil boring SB-28 was also consistent with the monitoring well measurements noted above.

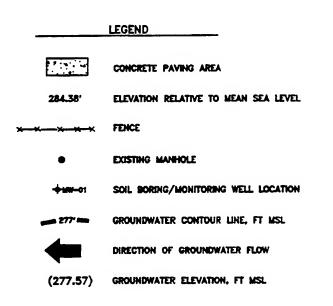
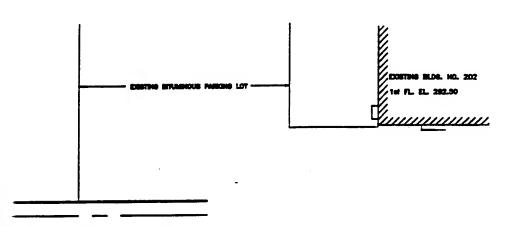
During the SA, it became apparent that bedrock beneath the MPA occurred at a somewhat shallower depth than in areas where the RI was conducted, and as a result, the shallow groundwater table occurred under confined conditions within the bedrock (Stockton Formation) beneath the MPA.

Borings installed to refusal (about 5 ft to about 18 ft BGS) during the initial SA did not encounter saturated conditions. As a result, air rotary drilling was used to advance four borings into the bedrock where water was encountered at approximately 21 ft BGS. Water levels obtained from monitoring wells installed in three of these boreholes (MW-01 through MW-03) on November 6, 1993, are presented in Table 2.2. A potentiometric surface map (Figure 3.6) was constructed using this information, and indicates groundwater flow in the Stockton Formation beneath the MPA is toward the north, from MW-01 toward MW-02 and MW-03. The hydraulic gradient between monitoring wells MW-01 and MW-03 was 0.017 ft/ft on November 6, 1993. During the SA in September 1994, groundwater was encountered in the unconsolidated deposits in one borehole (SB-28) at a depth of 17 ft BGS. Because groundwater elevations observed in MW-01 through MW-03 were generally consistent with data obtained in 1993, a separate potentiometric surface map was not prepared. Based on the measured groundwater elevations, a gradient of 0.017 ft/ft, an assumed effective porosity of 10%, and a hydraulic conductivity of 2.12 × 10⁴cm/sec (D&M RI), a calculation of groundwater velocity in the bedrock can be made using a modified form of Darcy's equation:

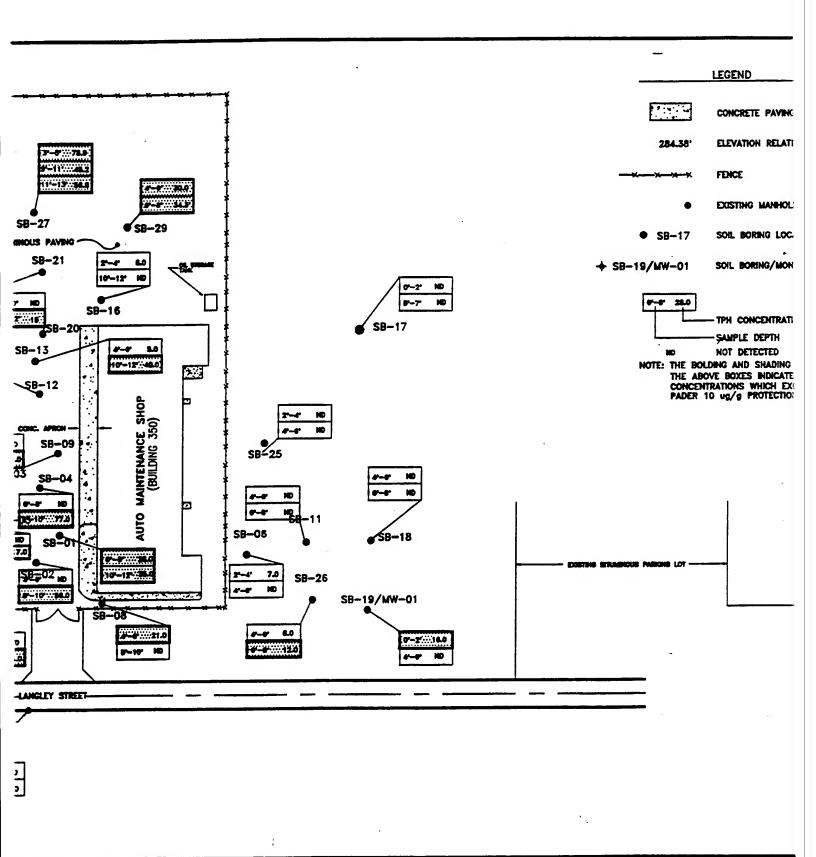
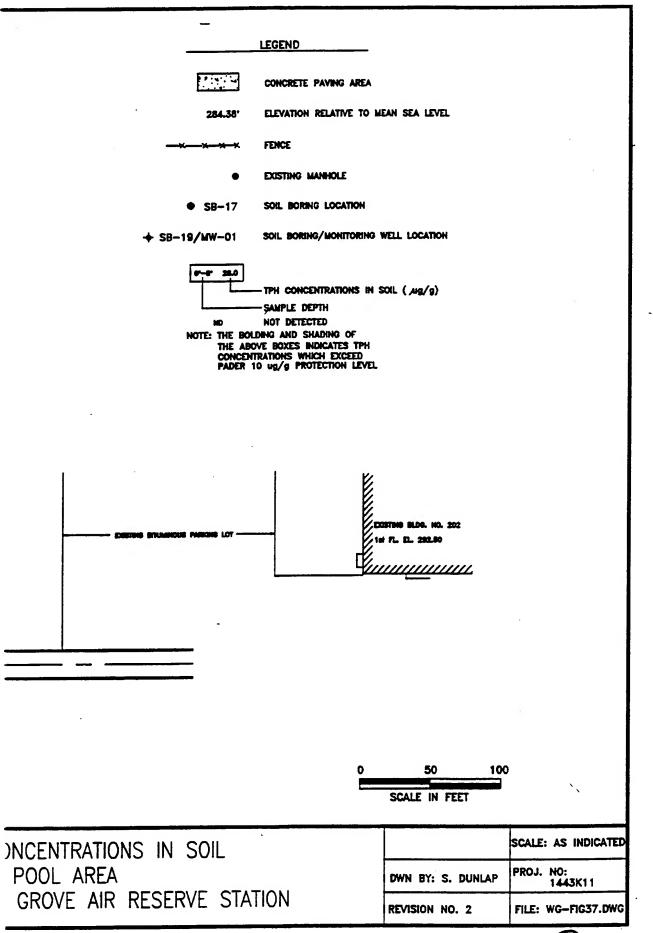
FIGURE 3.7 TPH CONCENTRATIONS IN SOIL

- impacts to the unconsolidated soils by TPH exist both within the MPA and in areas outside the MPA,
- concentrations of TPH in the soil ranged from non detect (less than 5 μ g/g) to 79 μ g/g,
- soil samples from four of the five borings submitted for laboratory BTEX analyses contained BTEX constituents (one sample exceeded the PADER Protection Levels), and
- groundwater is impacted by BTEX and TPH constituents at locations immediately downgradient of the former tank excavation.

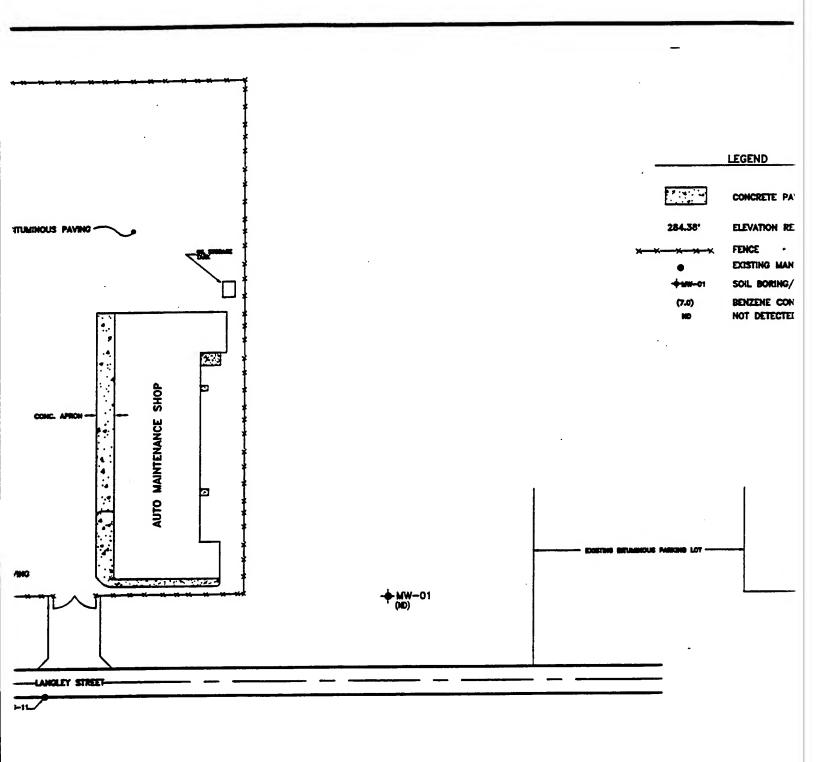
FIGURE 3.8 BENZENE CONCENTRATIONS IN GROUNDWATEF MOTOR POOL AREA, NOVEMBER 6, 1993 WILLOW GROVE AIR RESERVE STATION

Both groundwater samples which exceed the PADER MCLs were collected from monitoring wells located downgradient of the former tank system. Monitoring well MW-03 is located slightly down and sidegradient from the former tank system location. Monitoring well MW-02 is located directly downgradient of the former tank system. This location difference is the probable cause of the different benzene concentrations in the groundwater. The upgradient monitoring well did not contain detectable concentrations of BTEX or TPH constituents.

Groundwater samples obtained from the vicinity of the former UST location in 1993 contained concentrations of benzene in excess of 0.005 mg/L. Headspace screening was conducted in the monitoring wells using a PID during September 1994 in accordance with PEER's Health and Safety Plan, and the results are summarized below:

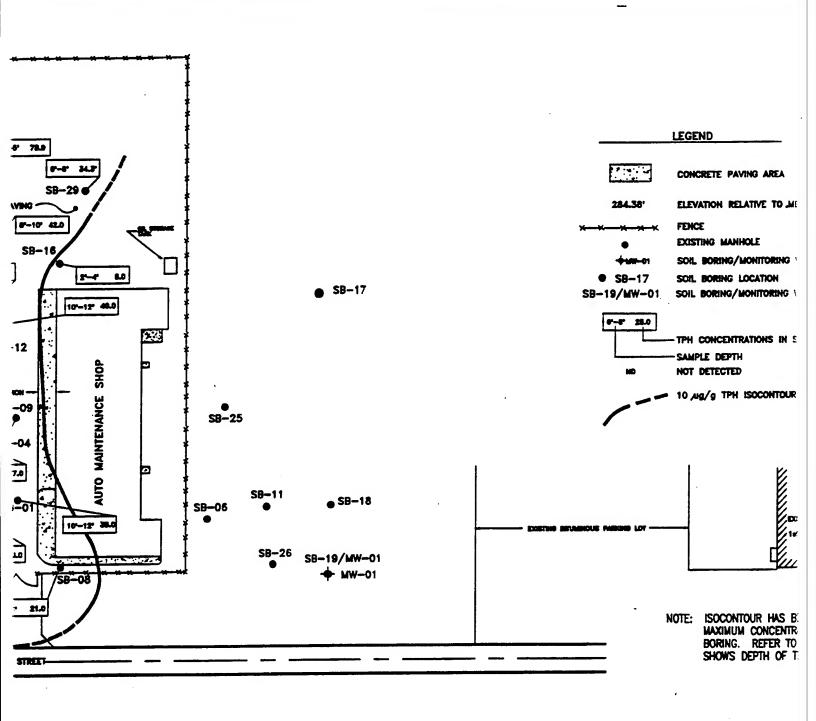
FIGURE 4.2 10 µg/g TPH ISOCONCENTRATION CONTOUR MOTOR POOL AREA WILLOW GROVE AIR RESERVE STATION

The area of soil impacted by TPH has been defined to the northwest, west, southwest, and east of the former UST. However, the boundary of TPH impacted soil toward the northeast has not been defined. The TPH impacted soils associated with the former USTs occur within the unconsolidated deposits. Generally the depth of impacted soils is 8 to 12 ft BGS in the vicinity of the former UST locations. This is consistent with a subsurface release mechanism, i.e., a leaking UST. As soil sampling proceeds toward the northeast, the depth to impacted soils decreases. Figure 4.1 presents a soil sampling profile along geologic cross-section line C-C' and Figure 4.2 shows a map of the soils which exceed the 10 μ g/g TPH protection level; i.e., soils which lie within this isocontour for the MPA. Figure 4.1 clearly illustrates the changing depth of maximum TPH impacts towards the northeast. These data tend to indicate that the shallow TPH impacts in the north eastern area of the MPA may result from surface releases and may not be a result of subsurface releases from the former USTs. The direction of groundwater flow toward the north and northwest further supports this hypothesis. Another possible soil impacting mechanism would be residual contamination left in the soil by seasonal variations in the water table. Greater concentration of TPH would be expected closer to the water table (i.e., at greater depth in the soil column) if this were true. Clearly in the northeastern area of the MPA, this is not the case.
